October 7, 2022

**Subject: Blue Gum Tree Risk Evaluations, North Vulcan Avenue, City of Encinitas, California**

This letter report summarizes the results of Dudek's assessment and provides recommendations for tree management.

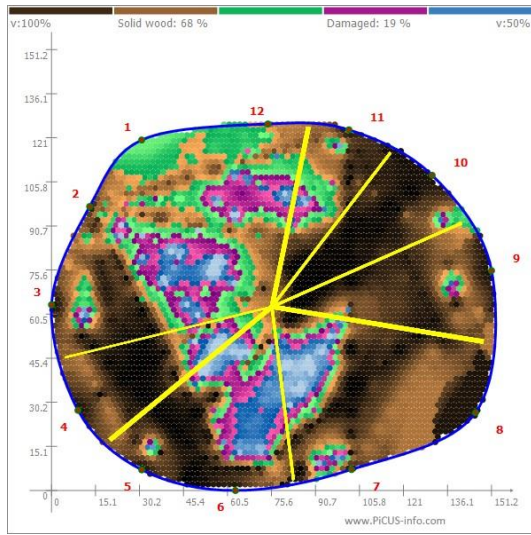
Tree No. 8242ETree – Remove

- **Removal of trees found to have high, very high or significant failure potential:** Dudek found five trees (8242, 8247, 8258, 8304, and 8268) that exhibited levels of internal degradation of 32% or more. Therefore, to minimize the risk associated with these trees, Dudek recommends they be removed and replaced. Removal of these trees will remove the overall associated risk. Detailed sonic tomography information can be found in Attachments 3 and 4.

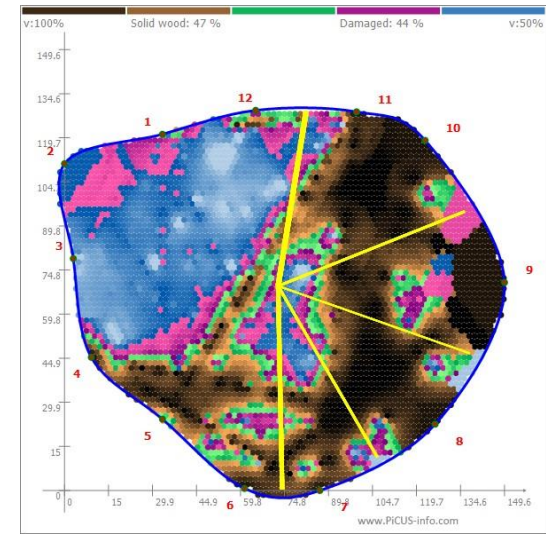
Tree No. 8247ETree – Remove

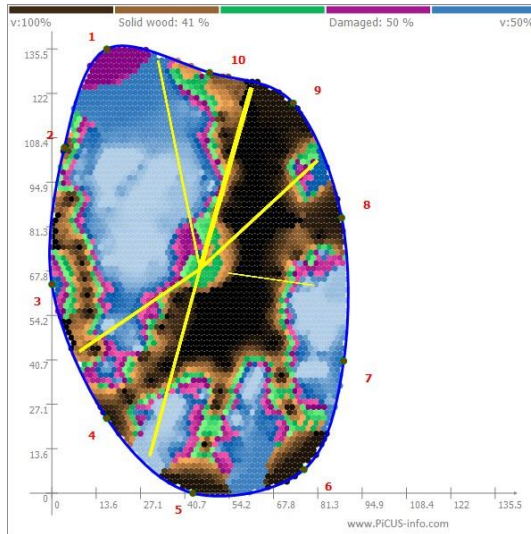
Tree No. 8258ETree – Remove

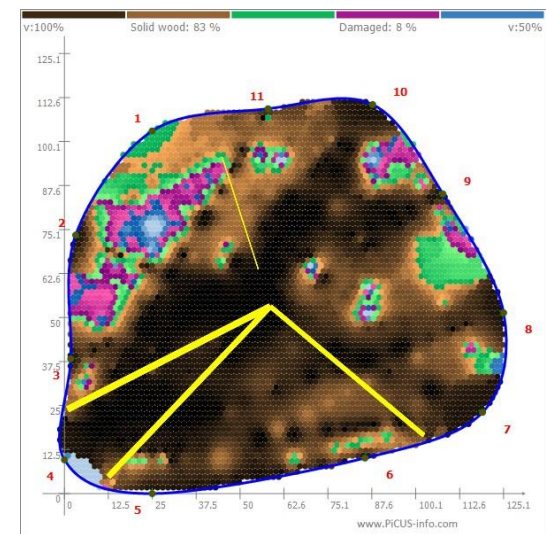
Tree No. 8259ETree – Monitor

- **Monitoring:** Five trees were found to have low to elevated levels of internal decay. As such, it is recommended that these five trees be inspected on an annual basis for signs of potential failure. Additionally, it is recommended that each of the five trees be evaluated with sonic tomography on an annual basis to track the spread of internal decay. Should the levels of internal decay reach a threshold of greater than 30%, it is recommended that the trees be considered for removal and replacement. These trees are also recommended for pruning, detailed in the next section.

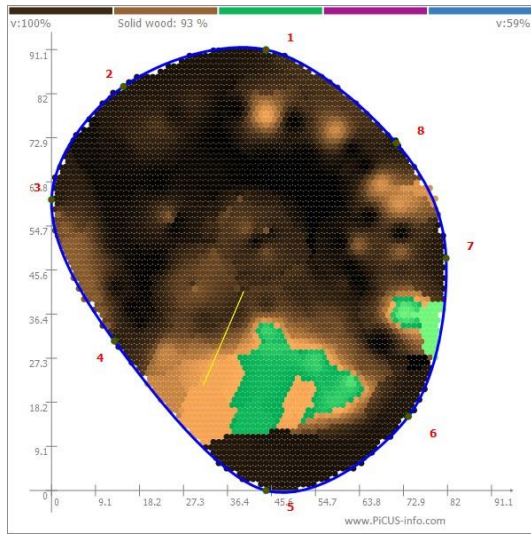
Tree No. 1062PWTree – Monitor

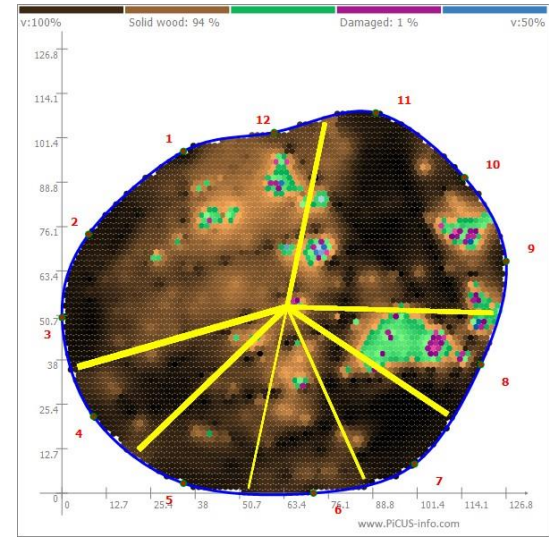
Tree No. 8310ETree – Monitor

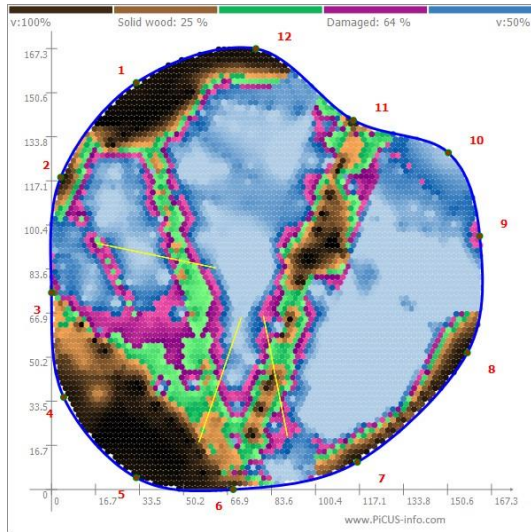
Tree No. 8304ETree – Remove

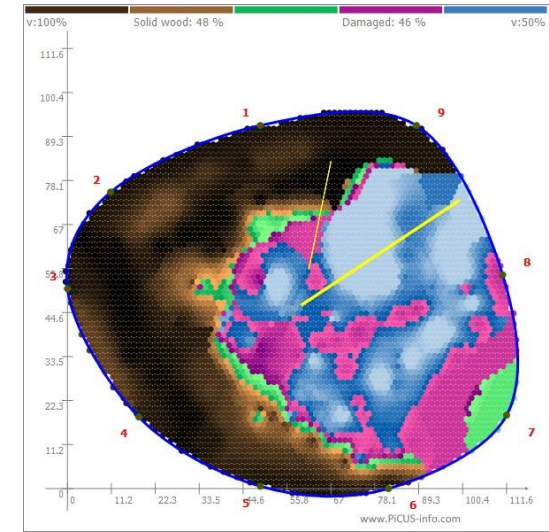
Tree No. 8268ETree – Remove

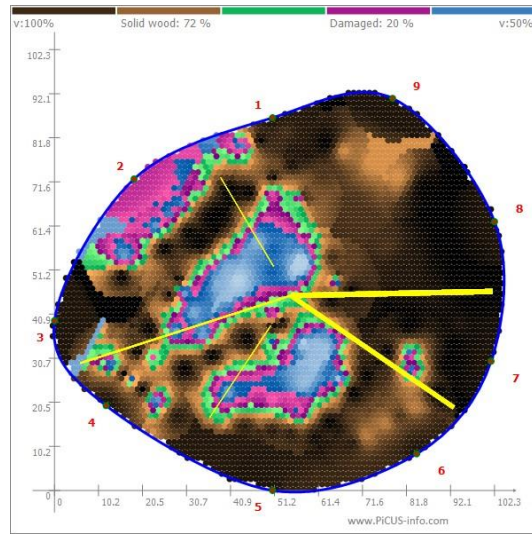
Tree No. 8266ETree – Monitor

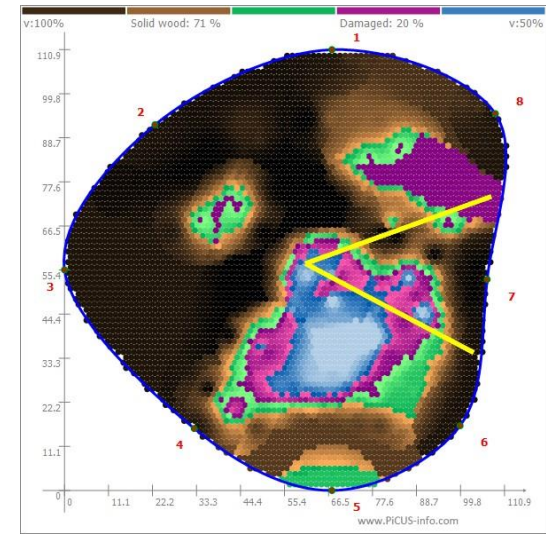
Tree No. 8265ETree – Monitor
